Dearborn, Michigan  
**NOISE-CON 2008**  
2008 July 28-30

## **Vibroacoustic response of residential housing due to sonic boom exposure: a summary of two field tests**

Two experiments have been performed to measure the vibroacoustic response of houses exposed to sonic booms. In 2006, an old home in the base housing area of Edwards Air Force Base, built around 1960 and demolished in 2007, was instrumented with 288 transducers. During a 2007 follow-on test, a newer home in the base housing area, built in 1997, was instrumented with 112 transducers. For each experiment, accelerometers were placed on walls, windows and ceilings in bedrooms of the house to measure the vibration response of the structure. Microphones were placed outside and inside the house to measure the excitation field and resulting interior sound field. The vibroacoustic response of each house was measured for sonic boom amplitudes spanning from 2.4 to 96 Pa (0.05 to 2 lb<sub>f</sub>/ft<sup>2</sup>). The boom amplitudes were systematically varied using a unique dive maneuver of an F/A-18 airplane. In total, the database for both houses contains vibroacoustic response data for 154 sonic booms. In addition, several t

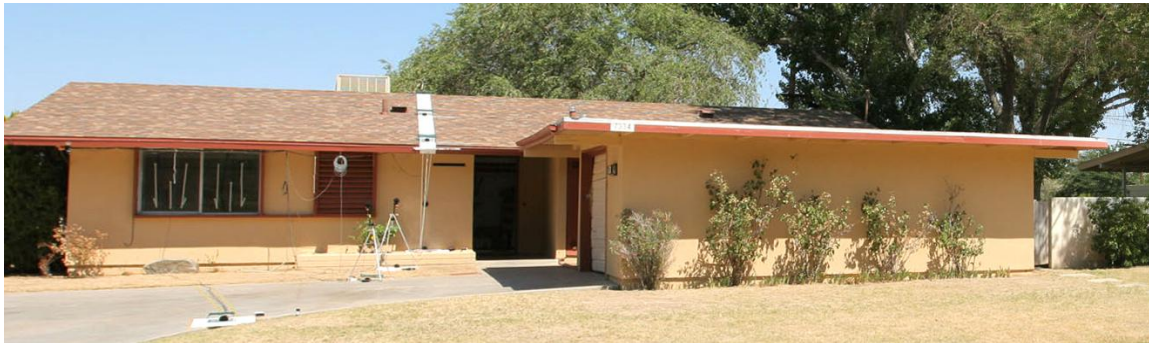
Figure 1: Photograph of the front of the house used in 2006.

The address of the house used in this experiment was 7334 Andrews Avenue, Edwards, CA. An exterior view of the house is shown in Fig. 1. The floor plan of this single story detached house is shown in Fig. 2. There are three bedrooms, one main living space, a kitchen, two bathrooms,

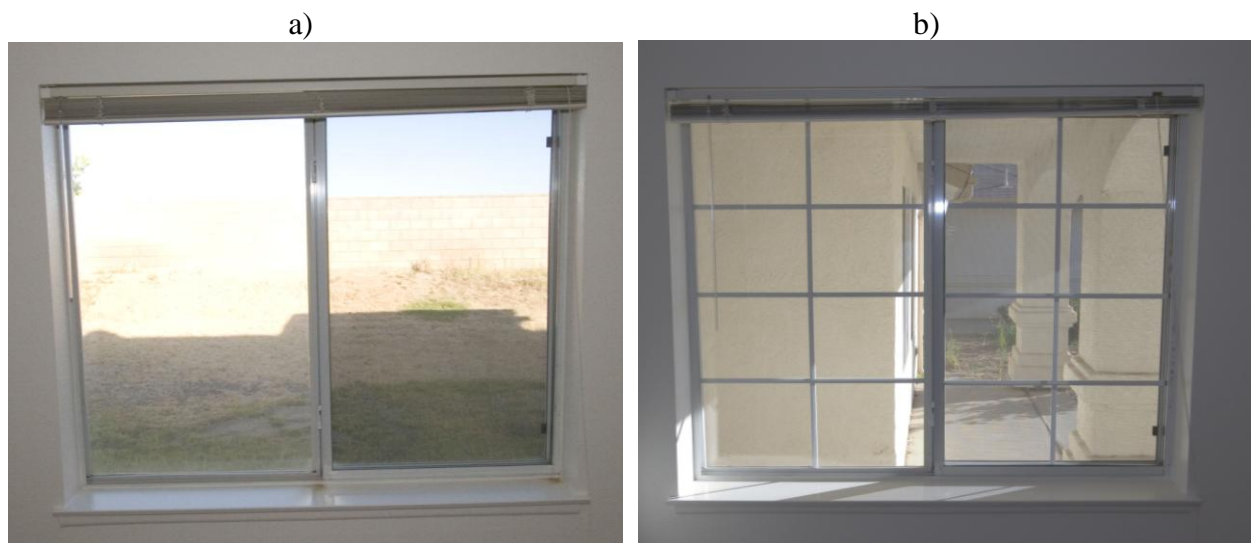
Figure 8: Photographs of the horizontal slider windows in a) the master bedroom and b) the front bedroom of the 2007 house. The right sash of the window is operable. The left is fixed.

truss framed, plywood sheathed, and finished with fiberglass shingles. This roof system formed an attic space above all of the rooms. R-38 fiberglass insulation bats were used in the attic above all of the rooms. Each bedroom had one window and the windows in these three bedrooms were horizontal slider windows, where each window consisted of two glazings (Fig. 8). Each glazing was a double pane insulated glass assembly. An aluminum sash held each glazing, and each sash was installed in a metal frame attached to the house. In between the sash and the frame was a pile type weather-stripping that significantly reduced the potential for direct metal-on-metal rattle at the sash-frame interface. The window in the bedroom by the front door differed from the windows in the other two bedrooms. This window had simulated muntin bars installed in-between the two insulated glass panes (Fig. 8b). These muntin bars were attached to the insulated glass spacer at the ends of each bar, but were not attached to either of the glass panes. Consequently, this lattice was free to vibrate in the gap in-between the two panes. Under even modest excitation of the insulated glass panes, these muntin bars would “slap” each pane as it oscillated back and forth, creating audible noise indoors.
